A year of intraoperative experience with Cochlear™ Nucleus® SmartNav System

J. Dallaire, H. Lancer, R. Irving, P. Monksfield
University Hospitals of Birmingham

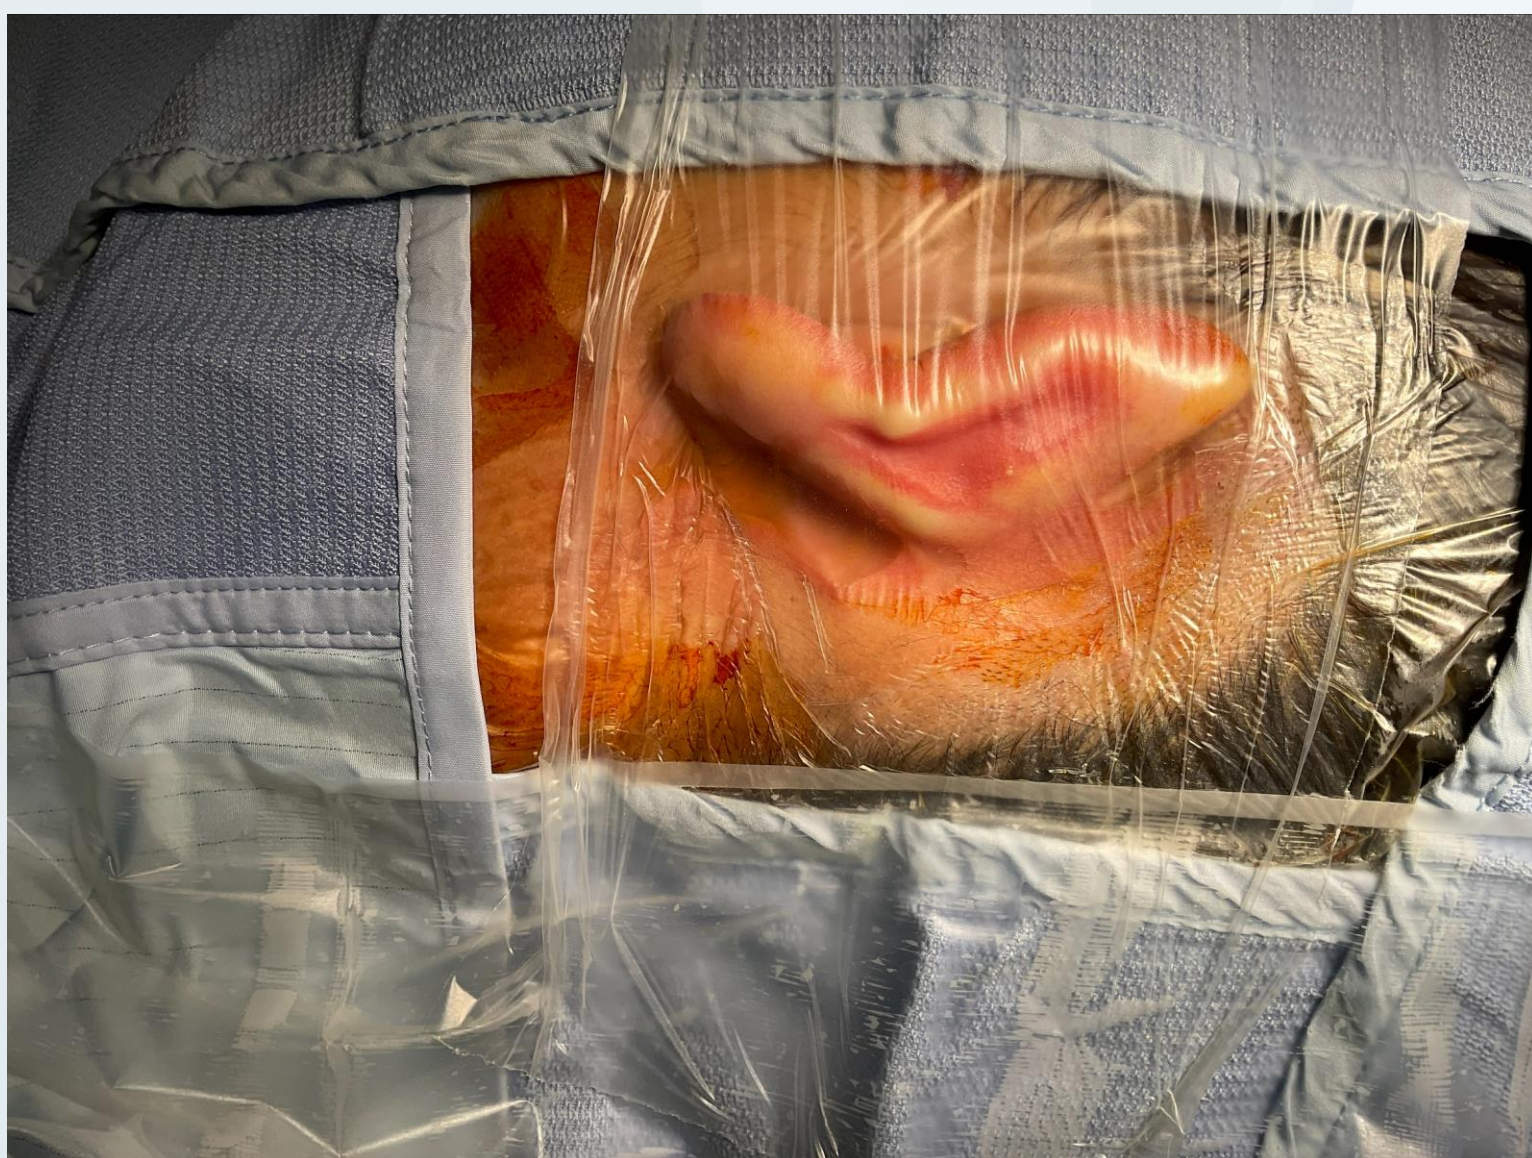
- ¾ surgeons used SmartNav for all their Cochlear surgeries.
- Surgeon's favourite feature was **unanimously post-insertion diagnostics** including Placement Check, Impedance and Auto-NRT.
- 2/4 thought the technology helped them reduce speed of electrode insertion.
- Magnet pairing of the processor** to the implant was initially challenging to all respondents.
- A change in draping technique was implemented, using a **thin adhesive drape** over the site of the implant. Pairing also became easier with the second release of SmartNav.

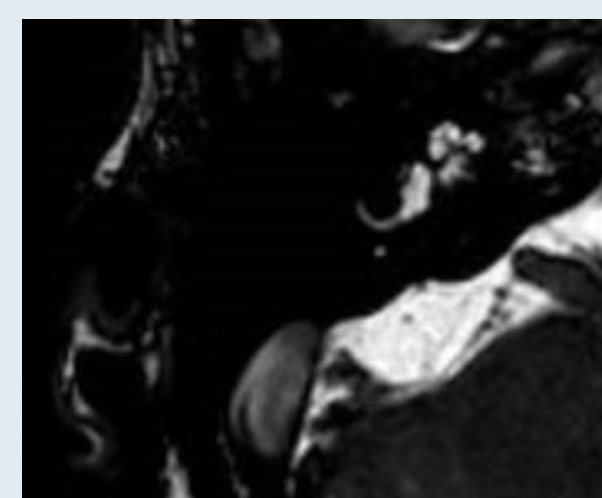
Fig 5. Pre-operative MRI

In a patient with a small cochlea, we encountered a profuse gusher on needle opening of the round window membrane. After slow insertion of CI622, SmartNav detected interactions and electrode was reinserted. Round window was packed with fascia. Second placement check with SmartNav confirmed correct placement of the electrode, also confirmed by post-operative CT-Scan.

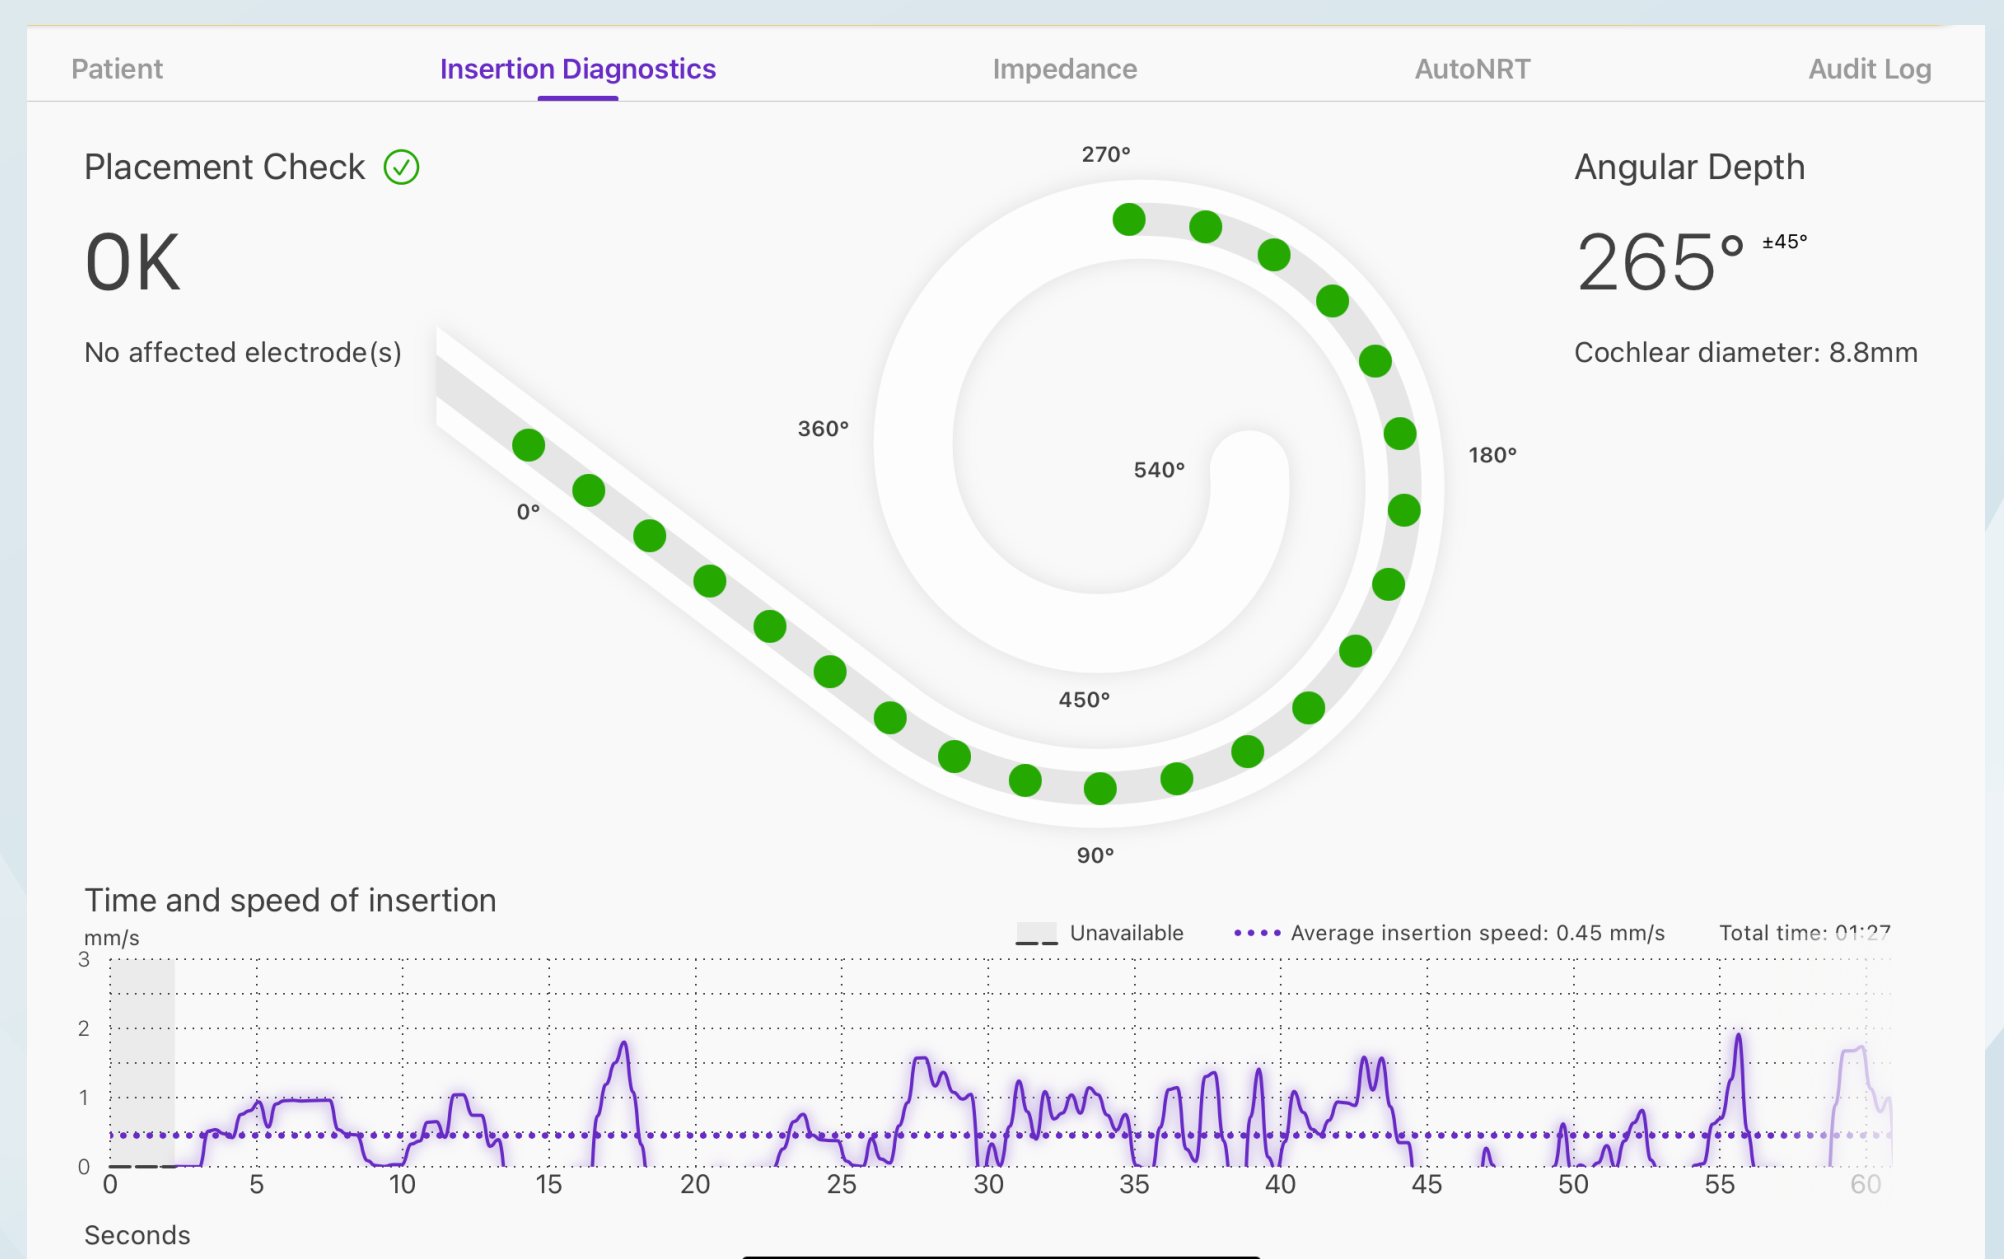
Fig 8 Initial display of SmartNav showing no tip foldover but low angular depth

In a patient with normal anatomy, SmartNav indicated correct placement of CI622 while routine post-operative X-Ray detected a tip foldover. Patient had revision surgery the next day and, on reinsertion, SmartNav detected a interactions. A new implant CI622 was used, and correct placement was confirmed by SmartNav and intra-operative X-Ray.
