Cochlear™ Osia®

Magnetic Resonance Imaging (MRI) Guidelines

FOR PROFESSIONALS

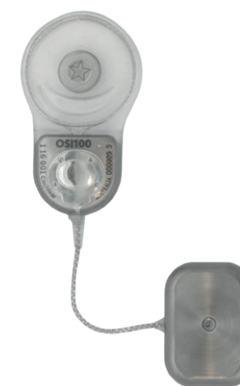
Fig.1: Approximate location of the OS100 Implant

Cochlear Osia implants are made of metal and implanted under the skin behind the ear. Use the *Fig.1-Fig.4* on page 11 to 12 to assist with identifying Cochlear Osia implants when using an X-ray.

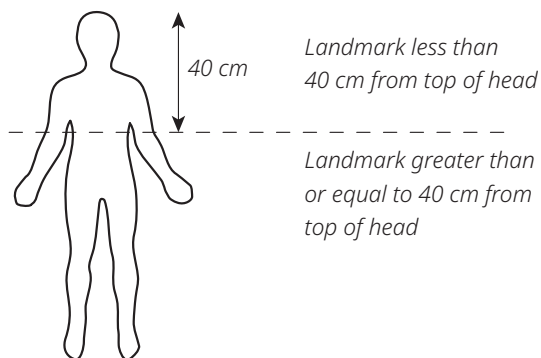
Fig.5: Landmark locations

- Transmit/receive head coils and whole body coils may be safely used within the recommended SAR limits. Refer to the MRI safety information and recommended SAR limit tables in the following pages.
- Local cylindrical transmit/receive coils may be safely used, without SAR restriction, provided that the distance between the entire implant and the end of the local RF coil is at least equal to the radius of the local RF coil.
- It is safe to use local cylindrical RF receive only coils with implants during MRI scanning, provided SAR limits for the transmit coil have not been exceeded.
- Local planar (flat linearly polarized) receive only RF coils should be kept more than 10 cm away from the implant.
